Figure 1
 General Site Location
 Gravity Survey
 New Paltz, New York

File 13G29

December, 2013

HAGER-RICHTER GEOSCIENCE, INC.
 Salem, New Hampshire

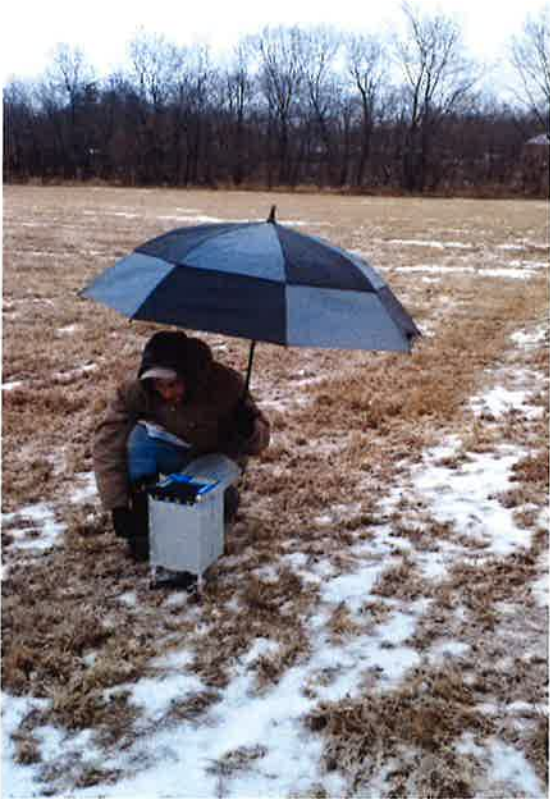
LINE 1

Figure 2
Site Photos
Gravity Survey
New Paltz, New York

These photos show the conditions along the survey lines at the time of data acquisition.

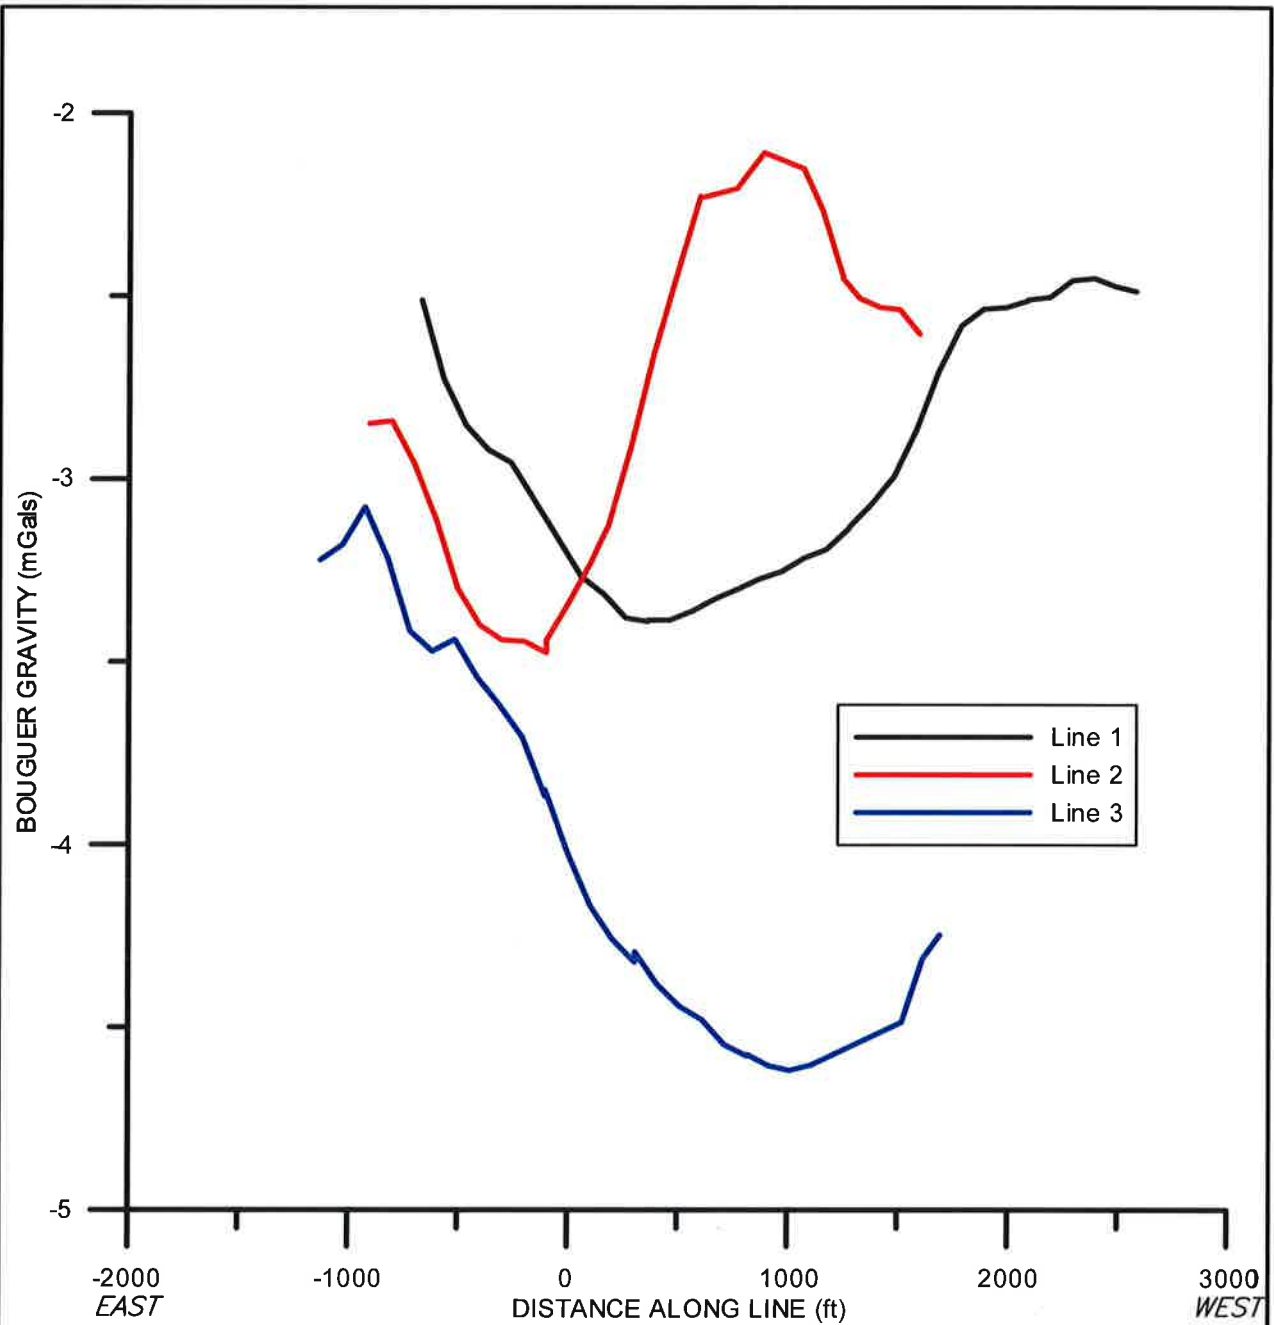
Figure 4
 Bouguer Gravity Anomalies
 Gravity Survey
 New Paltz, New York
